## PREVENTING TIDAL FLOODING AT PLANTATION ISLAND RESORT

Location: Malolo Island, Fiji  
Customer: Plantation Island Resort, Fiji

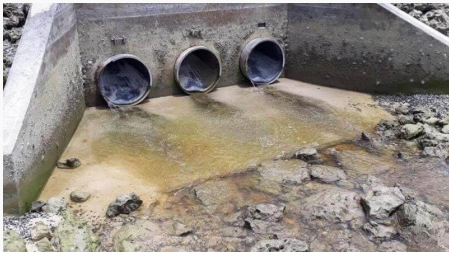
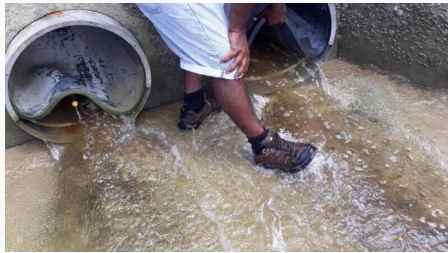
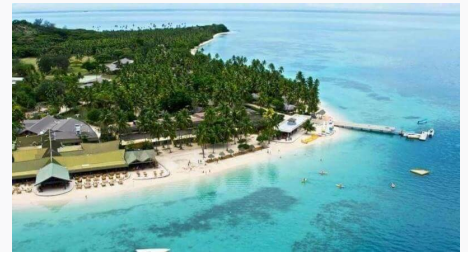
Tidal flooding occurring at Plantation Island Resort, was causing damage to the property and flooding in some rooms.

3 WaStop non-return valves were installed at the stormwater outfall and were tested immediately. The first day of operation saw a 2.4m tide - the highest level that is seen at Malolo Island. This was combined with 47mm rain which created flooding in the usual areas.

It was anticipated that the valves would create some upstream flooding given the extreme high tide but with only 100mm differential opening pressure, the valves functioned even when underwater.

Even with 2.4m tide, and heavy rain flooding was not experienced in the resort. The last time a 2.4m tide occurred prior to the installation of the valves, the incoming sea water was level with the top of the little bridge over the open drain pit near room 341 which caused flooding.
