## WASTOP PROVIDES PEACE OF MIND FOR THE RESIDENTS IN WHANGANUI, NEW ZEALAND

Location: Whanganui, New Zealand  
Customer: Whanganui District Council

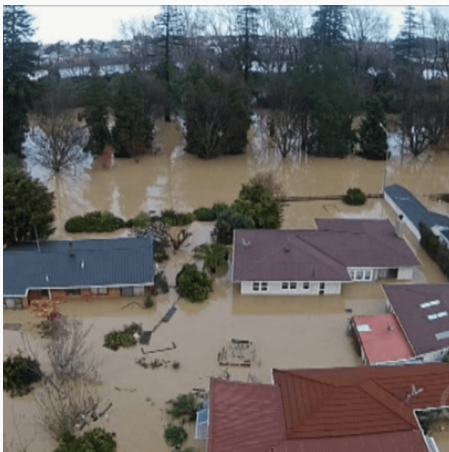
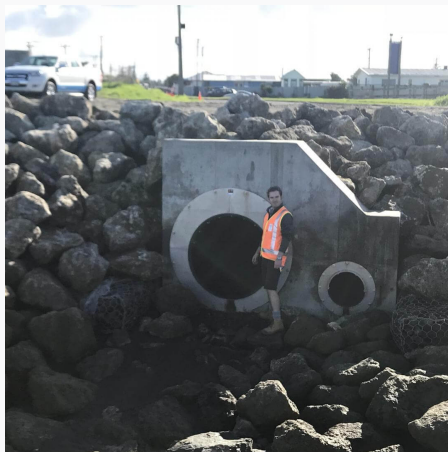
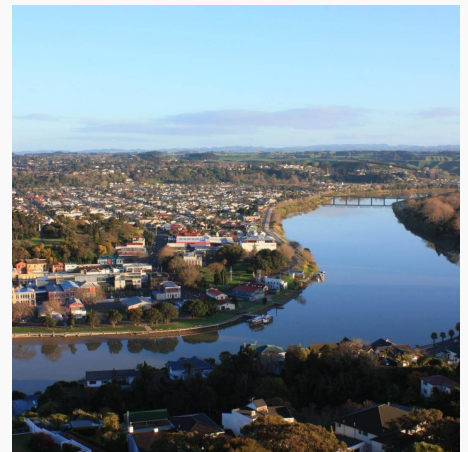
One of the causes of flooding is backflow from the river, through the stormwater outfall system. To prevent backflow, WaStop Inline Check Valves were installed on the outlet of these very flat DN1350, and DN450 concrete pipes. While the DN1350 pipe was a new line draining an industrial subdivision catchment, there was no backflow device installed on the DN450 line so this was upgraded at the same time.

With the WaStop in place backflow flooding has been eliminated, and the stormwater system can be used for attenuation during periods of high rainfall coinciding with high river levels.
