ENERGY SAVED AT STORMWATER PUMP STATION WITH WASTOP IN SWEDEN

Location: Stockholm, Sweden
Customer: Stockholm Water

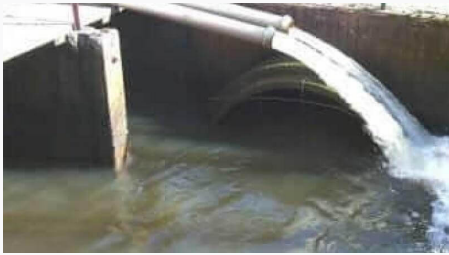
Stockholm WaStop

Wapro offered a WaStop NPS 30" as a solution. The existing opening and flange was measured and a customized WaStop was built to suit the pre-existing conditions. The WaStop was shorter than standard and the flange was placed in the middle of the valve to allow installation without any alterations to the existing building.
