ENERGY SAVED AT STORMWATER PUMP STATION WITH WASTOP IN SWEDEN

Location: Stockholm, Sweden
Customer: Stockholm Water

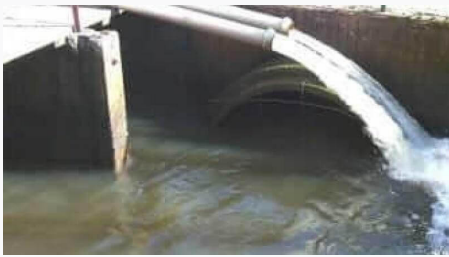
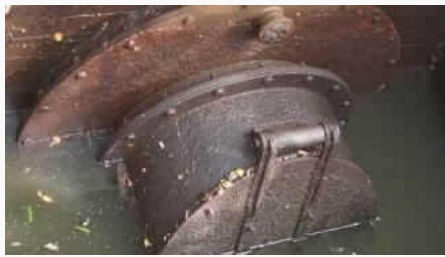
Stockholm WaStop

Wapro offered a WaStop NPS 30" as a solution. The existing opening and flange was measured and a customized WaStop was built to suit the pre-existing conditions. The WaStop was shorter than standard and the flange was placed in the middle of the valve to allow installation without any alterations to the existing building.

The WaStop valve has now been in operation since 2006 and hasn't required any repairs. It seals 100% and makes no noise when closing. WaStop valves have 16 feet. It was a perfect solution for this location with multiple problems.
