## WASTOP DN600 INSTALLED IN WOORI YALLOCK, YARRA VALLEY, VICTORIA, AUSTRALIA

Location: Woori Farmland, Yarra Valley, Australia  
Customer: Yarra Valley Council

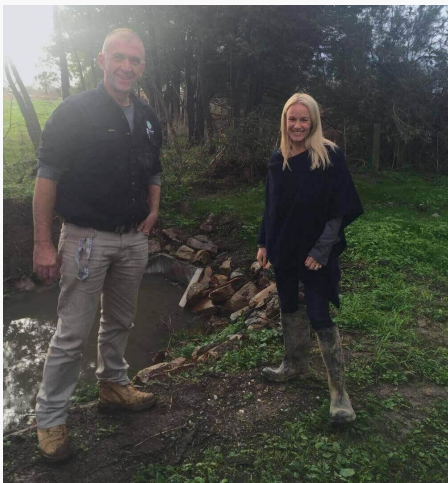
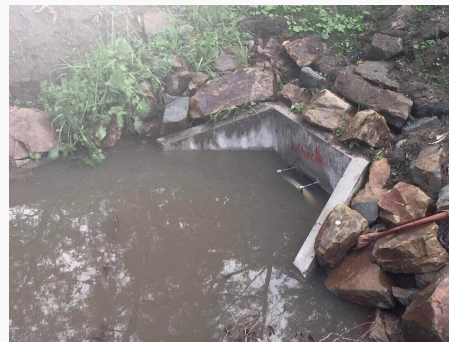
**WaStop Design:** A standard WaStop DN600 was installed in a headwall. The installation took roughly 30 minutes to complete.

A WaStop was installed to prevent the river from backing up into the creek, and leaving the stormwater system available for rainwater detention while the river is high. This has effectively stopped flooding and given the farmer peace of mind knowing his cattle are safe.
